RUSTMO1 SOLAR FARM

ENVIRONMENTAL COMPLIANCE MONITORING REPORT

EA Ref: 12/12/20/2147

Monthly ECO Report - August 2013
Submission to DEA &
RustMo1 Solar Farm (Pty) Ltd

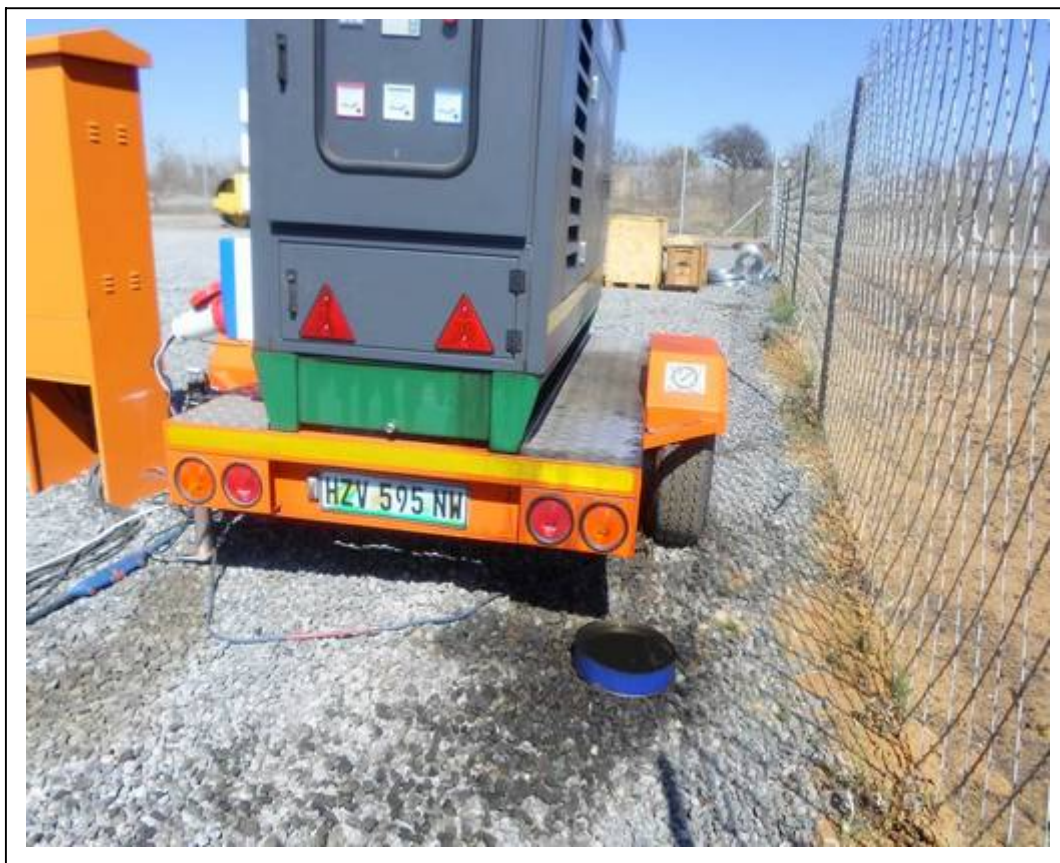
Oil spillages were found on the ground next to the generator (02 September 2013). This is mainly due to ineffective monitoring of the drip tray placed underneath the generator. The health and safety officer was advised to monitor the container and empty it often (refer to figure 1.).

Figure 1: Oil spillages surrounding the generator

A minor non-compliance was noted on site due to spillage of oils on areas surrounding the generator. Communication between the client, ECO, and the contractor remains good.

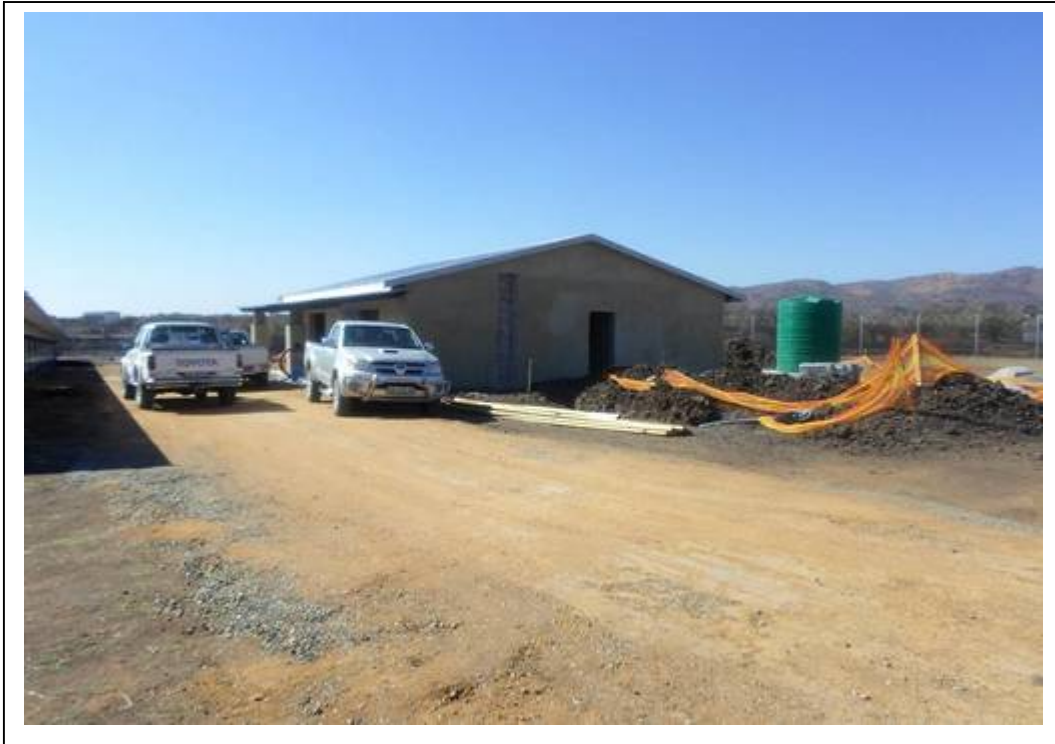
The subcontractor Pambele, is in the process of completing the Relay Room (Ceiling, Gutters, Painting and Flooring). All trenches dug are barricaded and no littering in the surrounding areas has been noted (see figure 2 below).

Figure 2: Relay room within the RustMo1 Solar Farm

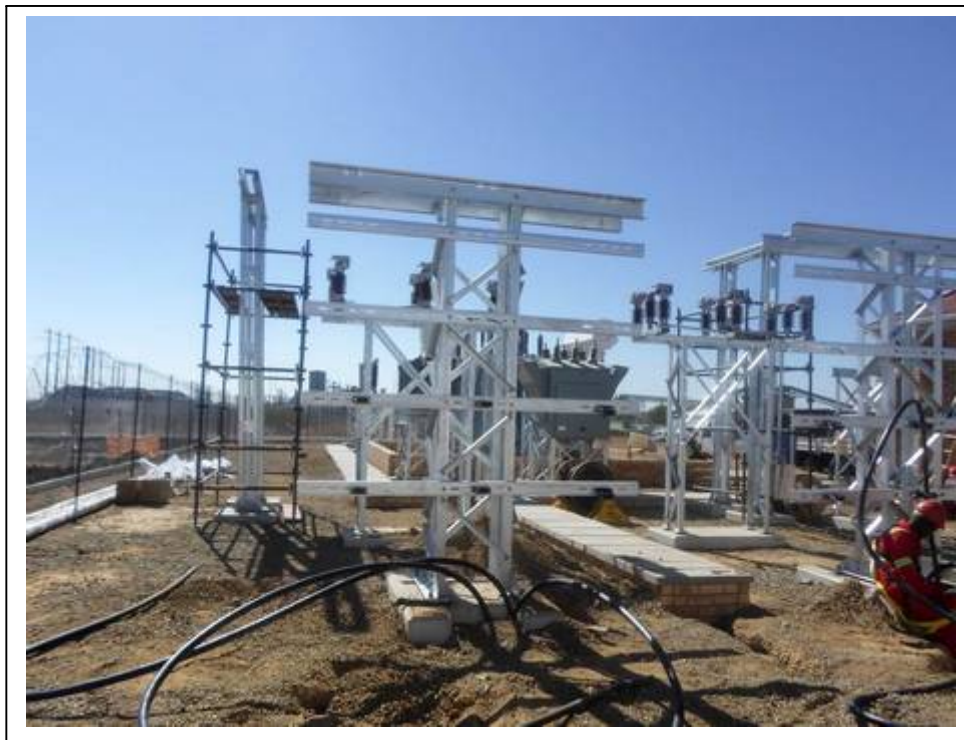
The subcontractor, Brand Engineering, lay control cables, assembled the 88 kV Isolator and 2x22 Isolator, construction Caps on 22kV Cable support and 22 kV Bus support. Furthermore, Pambele subcontractors were undertaking the construction of the 22/88kV substation (refer to figure 3 below).

Figure 3: Construction of a 22/88 kV substation on site
